Issue No. 142

*Supplementary October 2011*

# PRACTICE ADVISORY NO 13

## Egress Stairs: Earthquake checks needed for some

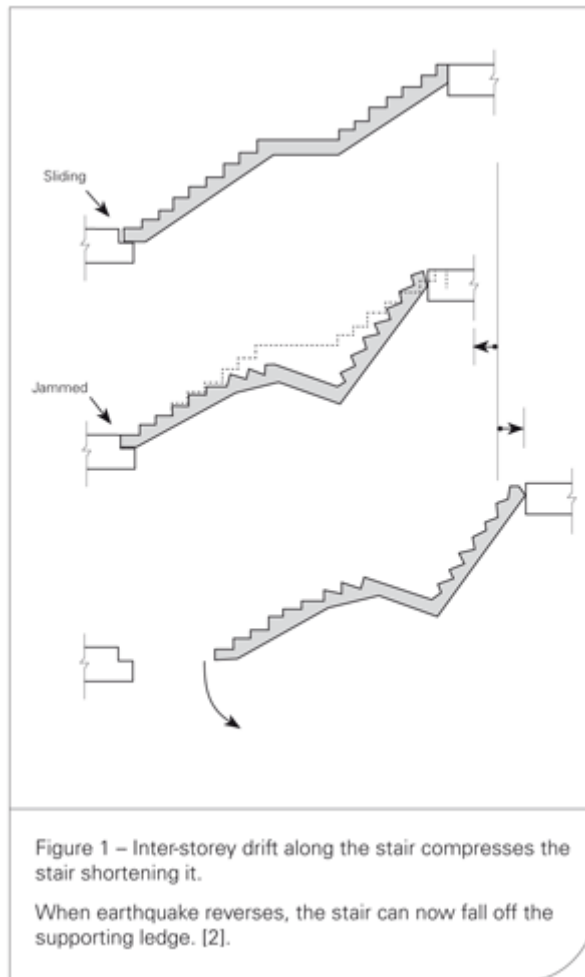
- If the relative lateral displacements between adjacent floors of a building (the “inter-storey drifts”) are sufficiently large, a stair may be pulled off the ledge that supports the sliding end of the stair.
- The seating dimensions allowed in existing designs may not be sufficient to account for movements now expected.
- The maximum inter-storey drift in estimates of building displacement may not adequately account for variability and uncertainty.
- Details that have limited scope to allow closing movement may cause damage to the stair flights. This damage may shorten the flights and make them more likely to fall off their supports.

- Check if the movement causes the sliding end of the stair to impact against the support (wall, beam or landing) - see Figure 1.
  - If the lateral movement of the stair closes the gap, causing impact on the support/landing:

- Look to increase the gap.
    - Check implications of bracing action as the stair struts between floors, if gap should close:
      - on the stair flight

- Check gap left for closing movement of the stairs:

- Check for objects in gap, such as debris or floor levelling compounds that may have occurred during earlier repairs/new fit-outs. Remove these obstructions.
- Modify detail to prevent further objects in the gap impeding movement. For example, cover plates over the gaps.
